# Customer Notification

**Notification No.:** 20240722

**Description:** iVIZION® Banknote Acceptor Grounding

**Hardware:** iVIZION® Banknote Acceptor

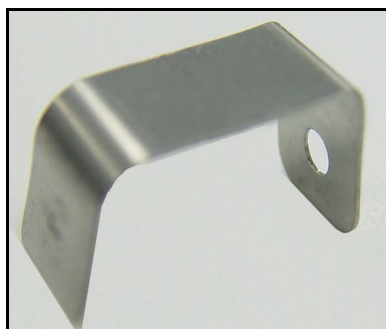
**Figure 1** Frame Ground Plate

- Loose nuts on Frame Ground Plate (see Figure 1);
- Frame Ground Plates not installed (missing) (Figure 2);
- Frame Ground Plates not installed properly (Figure 3).

Visually inspect the iVIZION rear harness connector to confirm the Frame Ground plate is installed. Ensure the Frame Ground Plate is securely attached over the rear harness connector, and the securing nut is tight (Figure 5).

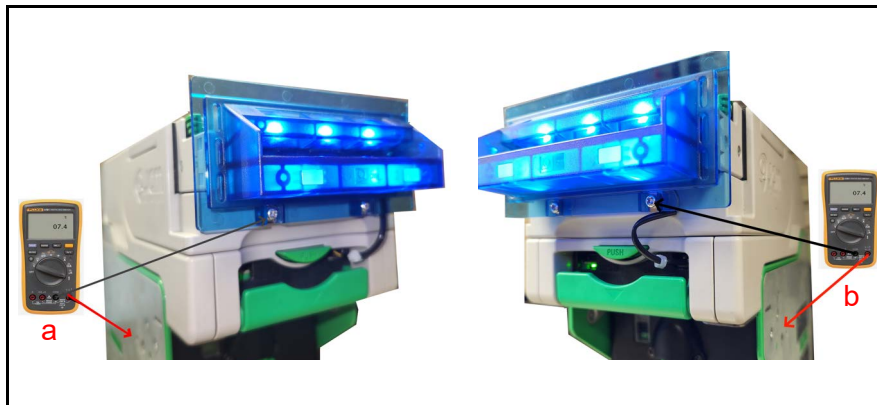
**Figure 4** Resistance Measurements  
(Left/Right Sides of iVIZION Chassis Frame)

To confirm grounding is within specification, use a multi meter and measure the resistance between the Bezel Mount Screw and the iVIZION Chassis. Resistance should be less than 10 ohms on both the left side (Figure 4 a) and right side (Figure 4 b).
